Streambank stability

This Fact Sheet is the second in a series dealing with the management of riparian land.

FACT SHEET 2

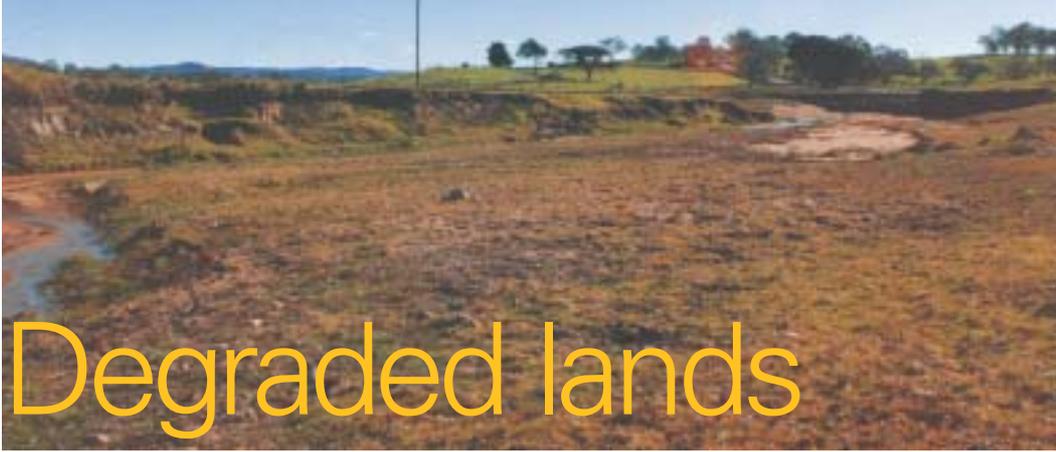
Large scale clearing of vegetation has degraded riparian lands and increased stream erosion.

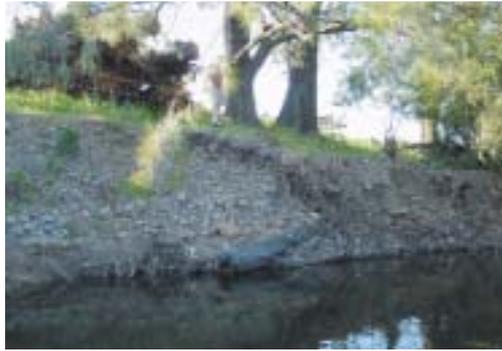
The stream is scouring the toe of this streambank which has no riparian vegetation to prevent this erosion from occurring.

- **Scour** — This occurs when the force applied to a streambank by flowing water exceeds the resistance of the bank's surface to withstand those forces. This often happens at the toe of the bank (i.e. at the water's edge) where suspended particles in the flowing water scour away the bank soil. It is also common on the outside bends of rivers, where the flow speed is fastest. Again, protecting the bank and reducing flow speed are critical actions to reduce this form of bank erosion.

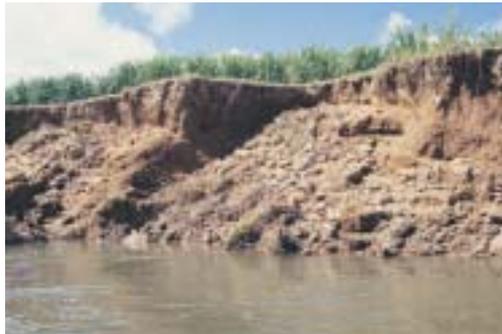
The removal of riparian vegetation has resulted in streambank erosion and the collapse of large sections of the bank.

- Slumping — This occurs when blocks of the bank collapse as a result of undercutting or other structural weakness within the streambank. The reinforcing effect of plant roots, and removal of moisture through plant use, can assist in reducing slumping processes in many situations.

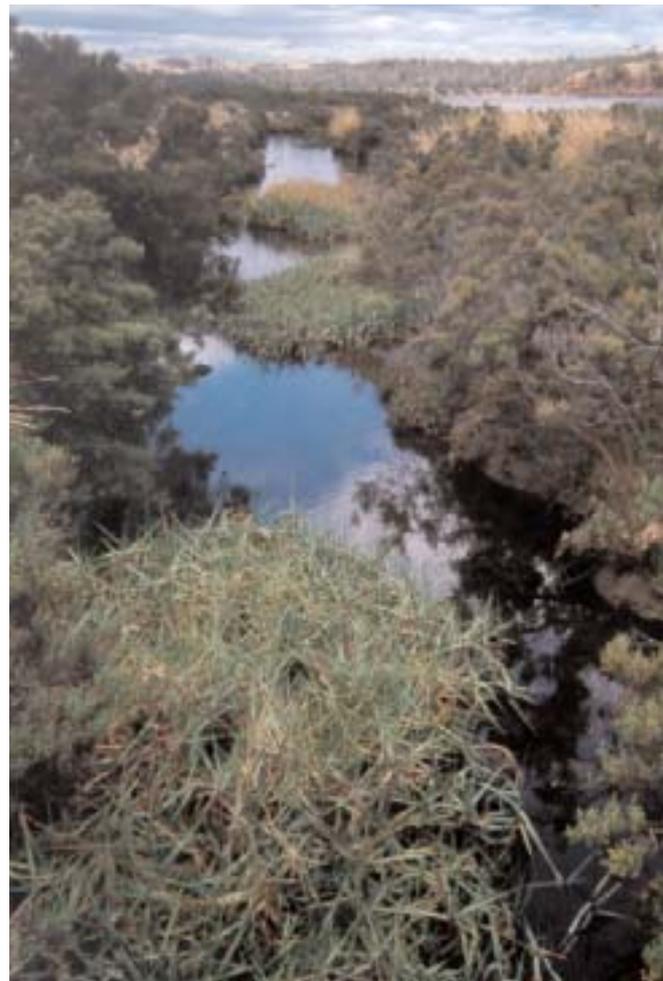
Exotic rice grass invading a small creek.

In some cases, highly-invasive vegetation may grow into the river channel. Vegetation growing within the channel will reduce scour by decreasing the flow speed adjacent to the bank. However, if the vegetation becomes too dense, for example in the case of reed beds or some invasive exotic grasses, it can direct flow into the banks and increase scour. As well, lower flow speed in channels invaded by vegetation, especially willows in southern Australia, can reduce channel capacity. The result may be an increase in the frequency of nuisance flooding.

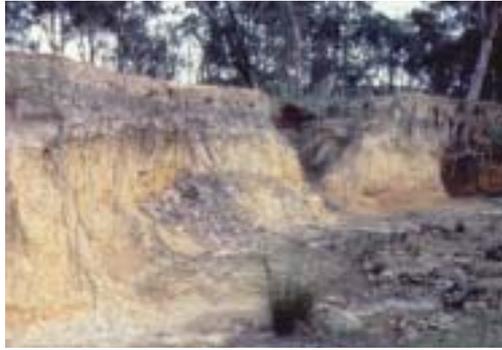
Stream incision.

- Incised streams — This occurs when the bed is deepening and the banks fail because they are over-steep and perhaps undercut. There is little point, in this situation, in stabilising streambanks until the streambed has been made stable. Vegetation on the channel or gully floor, while being very difficult to establish, is useful in stabilising the bed, although some initial grade control structures using rock or large woody debris may be needed. It is important that dense vegetation does not then fill the centre of the channel and divert flow onto the banks. In some cases, the best management is simply to fence the stream off from grazing, stabilise the bed with rock or woody debris, and allow the bed and banks to be colonised by grass. Another approach is to construct a stabilised rock riffle within the channel, positioned so as to retain an upstream pool that acts as a stilling pond during flow events, helping to protect the bed from further erosion.

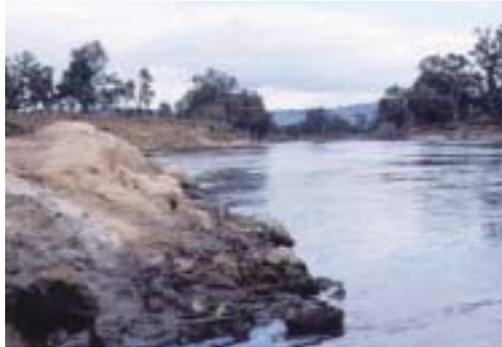
Channel widening.

- Channel widening — This may or may not be related to incision. If both banks of a stream are eroding, it may be that:

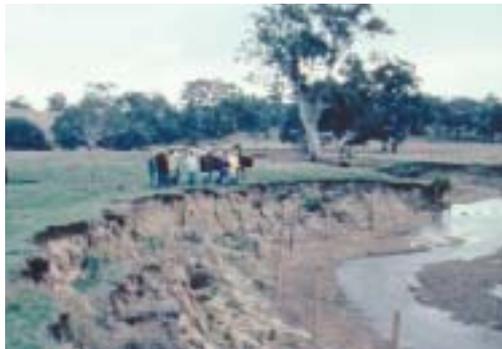
Erosion of the outer bank.

- Erosion of the outer bank — This usually occurs on steep banks located on the outside of a meander bend. This is the most common erosion problem faced on larger streams. The outside bank of a meander is often steep or even vertical, making it difficult to establish vegetation on the bank face. In general, the higher the bank, the less useful vegetation on the top of the bank is in reducing collapse. In other words, revegetation on its own is likely to be effective only when there is an approximate match between the height of the bank and the rooting depth of the vegetation.

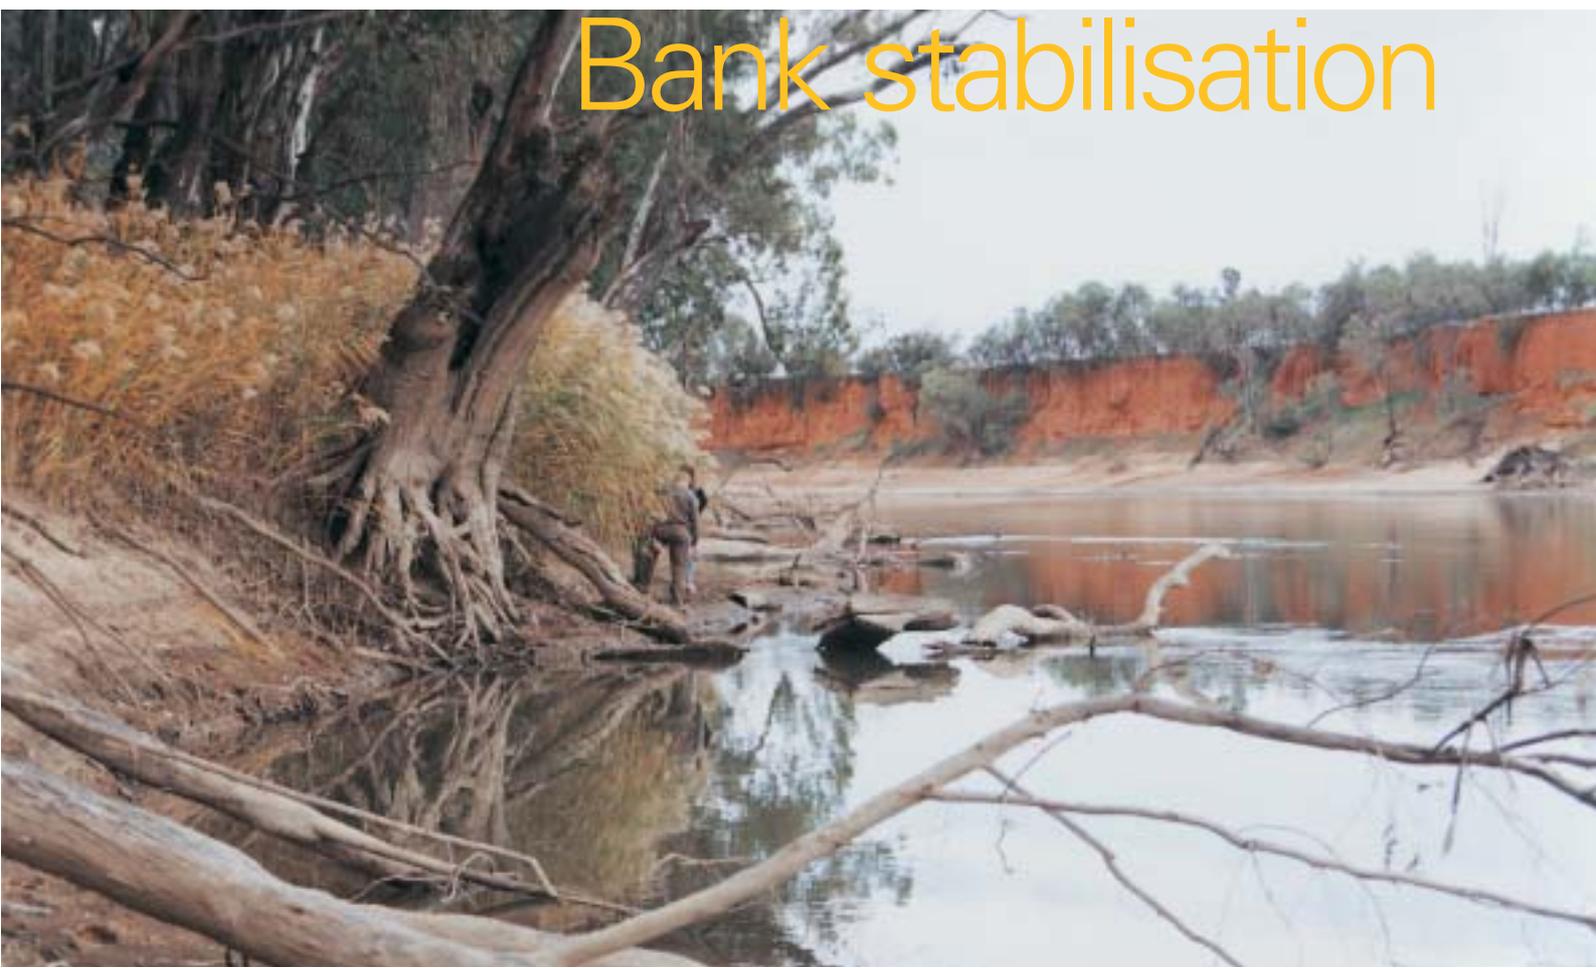
Phragmites growing over the bank of the Murrumbidgee River helping stabilise it against scour. Note also the protection from tree roots and the contrast with the vertical bank on the outside of the bend.

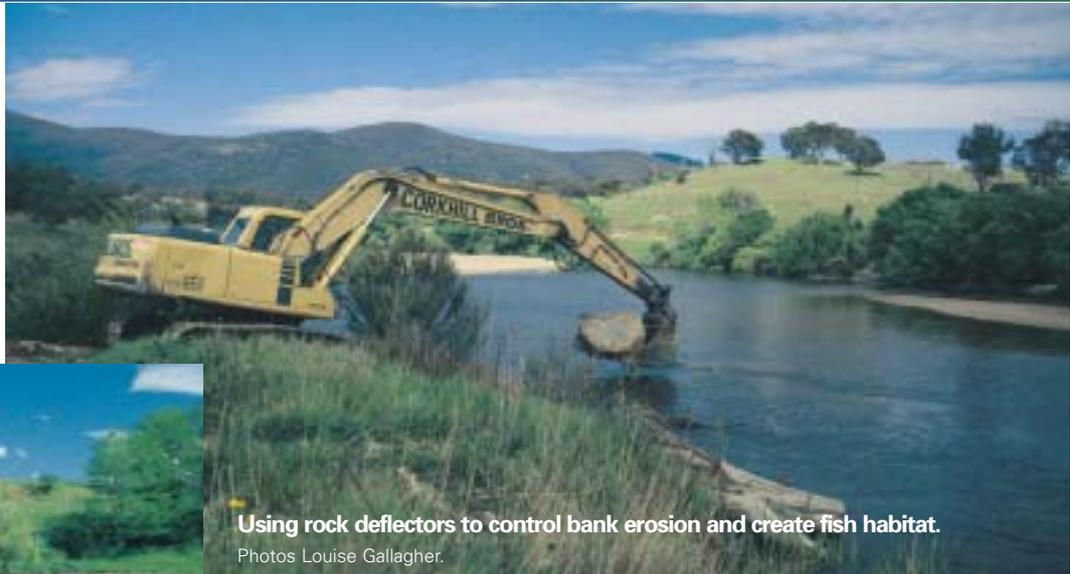
Using rock deflectors to control bank erosion and create fish habitat.
